DESCRIPTION

FRONT RADIUS ARM REAR BUSH ANTI PULL

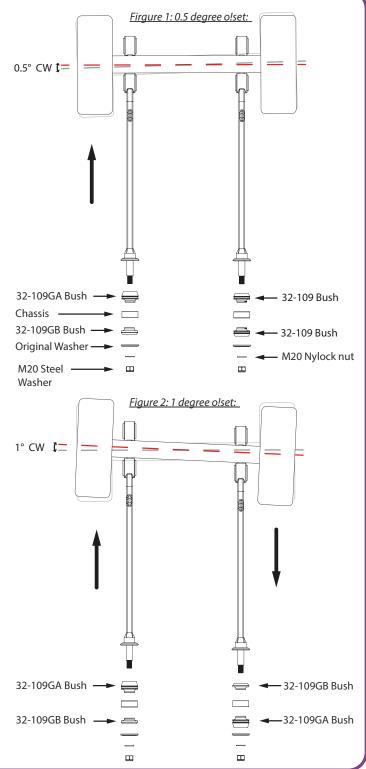
2. If the front axle steering misalignment is unknown use the 0.5 degree offset setup.

(As shown in figure 1)

2. If the 0.5 degree offset setup (As shown in figure 1) does not fully correct the pull on the vehicle to the left, then use the 1 degree offset setup.

(As shown in figure 2)

This part is designed to correct the misalignment of the front axle that causes the vehicle to pull to the left. The kit includes parts to correct both 0.5 and 1 degrees axle misalignment.
